# PAVEMENTS AND STUDED TIRE DAMAGE

## WSDOT - State Materials Laboratory

### **UPDATE: December 2008**

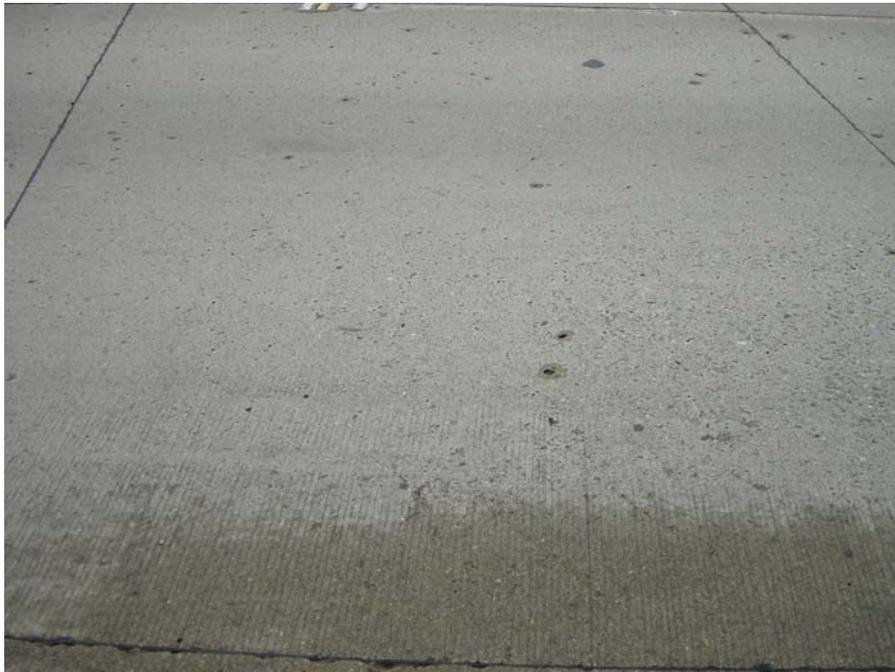
16 year old concrete pavement, Washington: Photo 6 shows a 16 year old concrete pavement constructed in 1989 on I-90 in Seattle in the vicinity of Rainier Avenue (photo taken in 2005). This pavement has an average annual daily traffic of 120,000 vehicles.

Photo 6. Concrete pavement on I-90 in Seattle (Rainier Avenue).  
ADT: 120,000 vehicles  
Pavement Age: 16 years

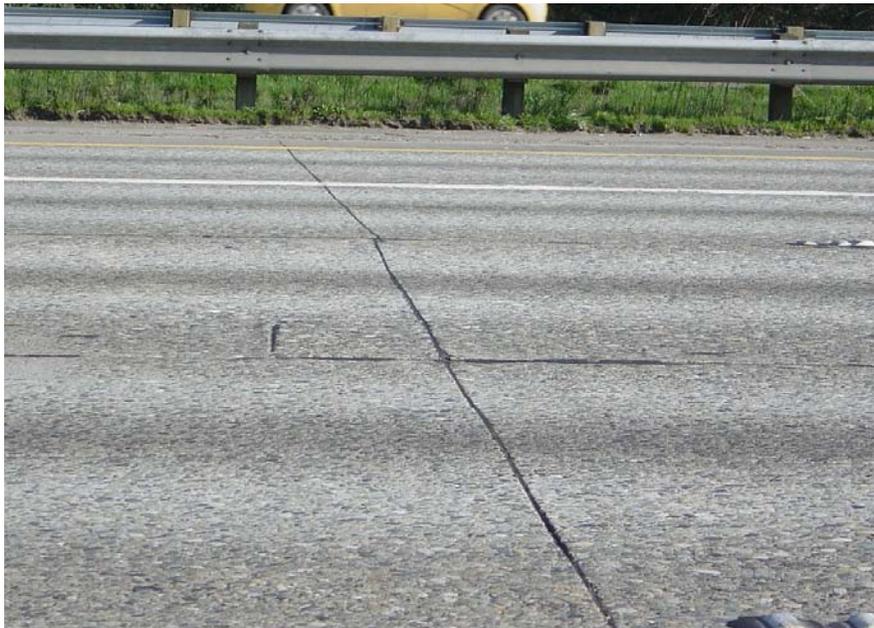
34 year old concrete pavement, Washington: Photo 10 shows a 34 year old concrete pavement constructed in 1967 on I-5 in Seattle in the vicinity of Boeing Field (photo taken 2005). The average annual daily traffic on this section of pavement is 204,000 vehicles.

Photo 10. Concrete pavement on I-5 near Boeing Field.  
ADT: 204,000 vehicles  
Pavement Age: 34 years

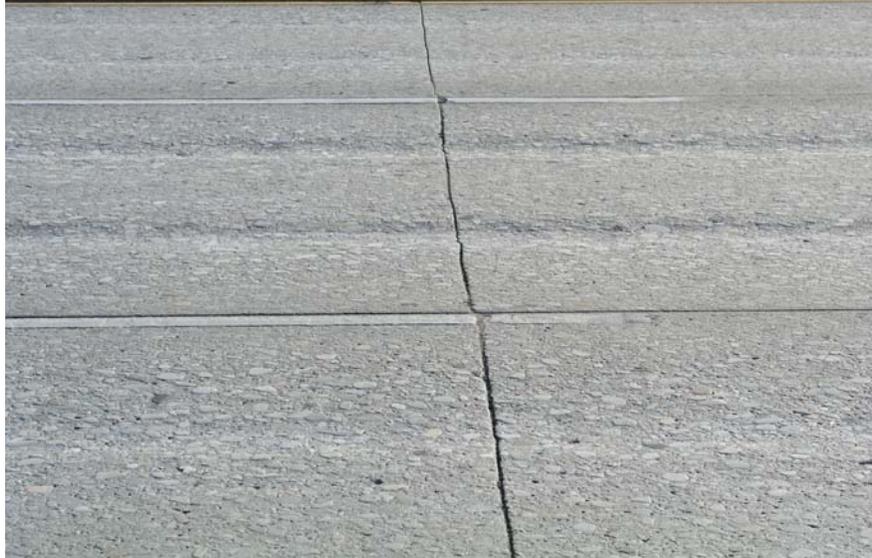
48 year old concrete pavement, Washington State: Photo 12 shows the concrete pavement surface on I-90 in Spokane, vicinity of Altamont Street that was constructed 48 years ago, in 1958. This section of I-90 has an average annual daily traffic of 100,000 vehicles. What is interesting to note on this pavement section is that in 1995 WSDOT conducted a rehabilitation project to diamond grind the existing surface to remove studded tire damage, 11 years later the studded tire wear continues to develop and is visibly noticeable (photo taken 2006). This photo also shows all three lanes on this highway section. The bottom of the photo is the far right lane and the top portion of the photo shows the far left lane. Another characteristic that is typical of studded tire wear is that on multi-lane facilities (3 or more lanes in one direction) the middle lane generally has the most severe studded tire damage (i.e. the location of the majority of the passenger vehicle traffic).

Photo 12. Concrete pavement on I-90 in Spokane.  
 ADT: 100,000 vehicles  
 Pavement Age: 48 years

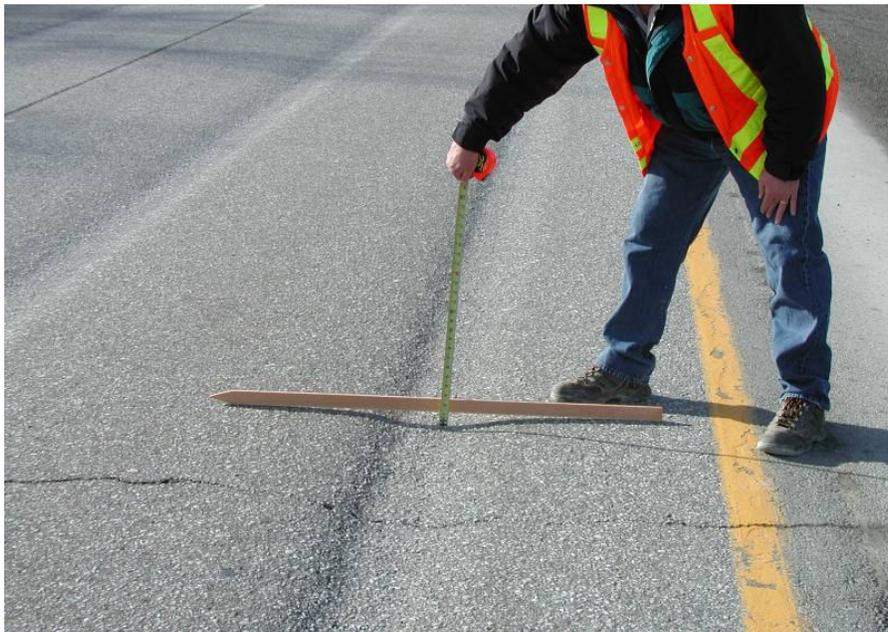
Photo 15 shows a close-up of an open-graded hot mix asphalt pavement that has been damaged by studded tires. This pavement was originally placed in 1992 and was replaced three years later due to the significant rut caused by studded tires (approximately 1-½ inches deep).

Photo 15. Studded tires raveling on hot mix asphalt pavement on I-90 vicinity of Idaho border.

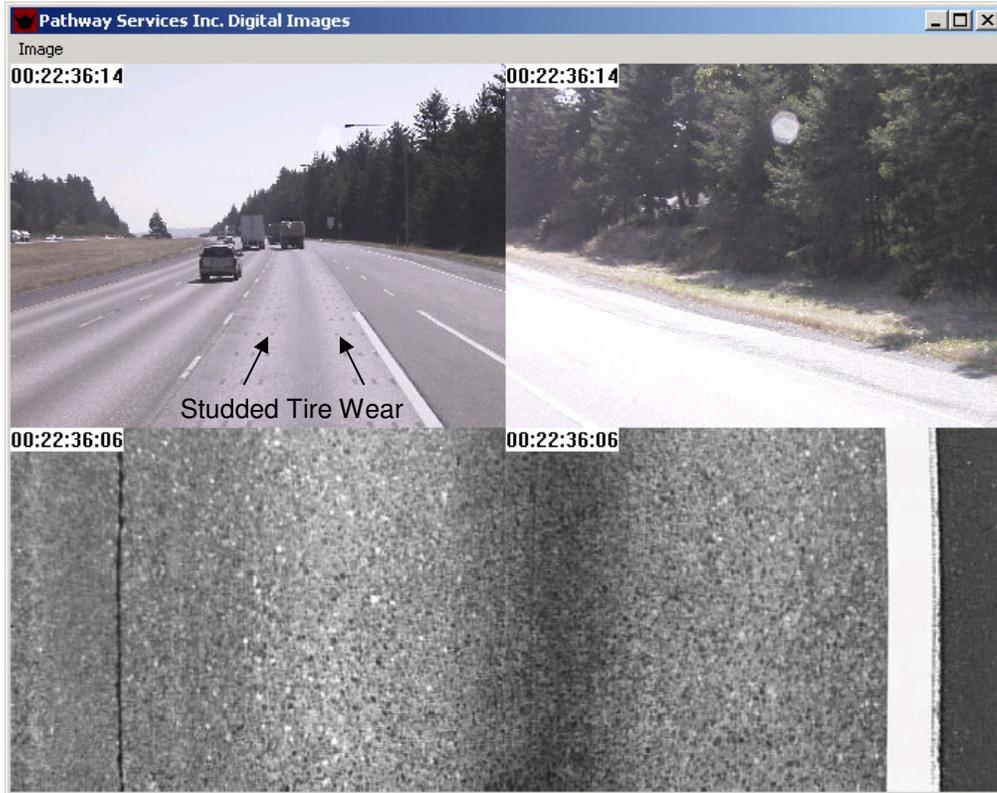
Photo 18. Pavement view in location of studded tire wear (I-5, northbound, milepost 112.23, Lacey vicinity, concrete pavement).

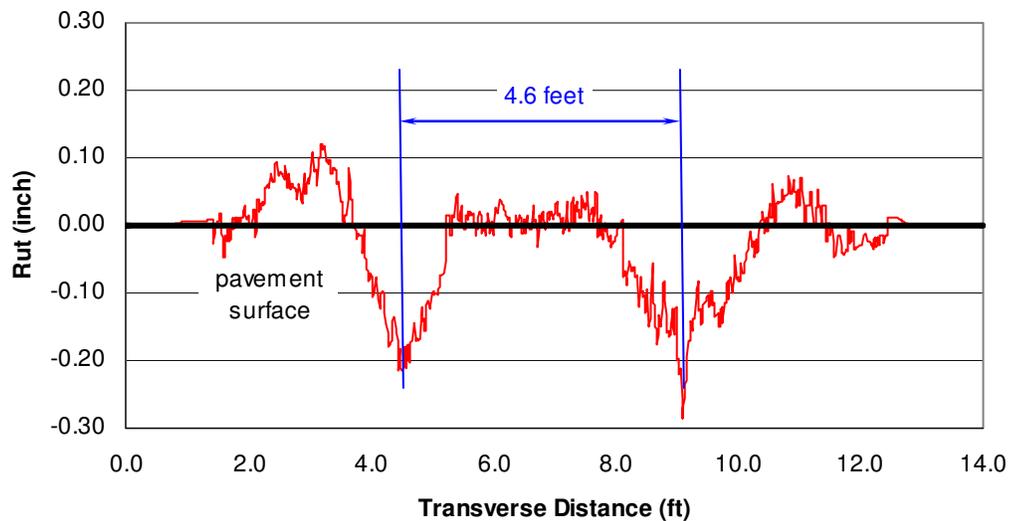
Figure 2. Transverse profile in an area of studded tire wear (I-5, northbound, milepost 112.23, Lacey vicinity, concrete pavement).

entirely due to studded tires and shows a loss of material from the pavement. The example on hot mix asphalt pavement ruts are from shoving (or plastic flow) where the pavement has been physically deformed by heavy truck traffic.

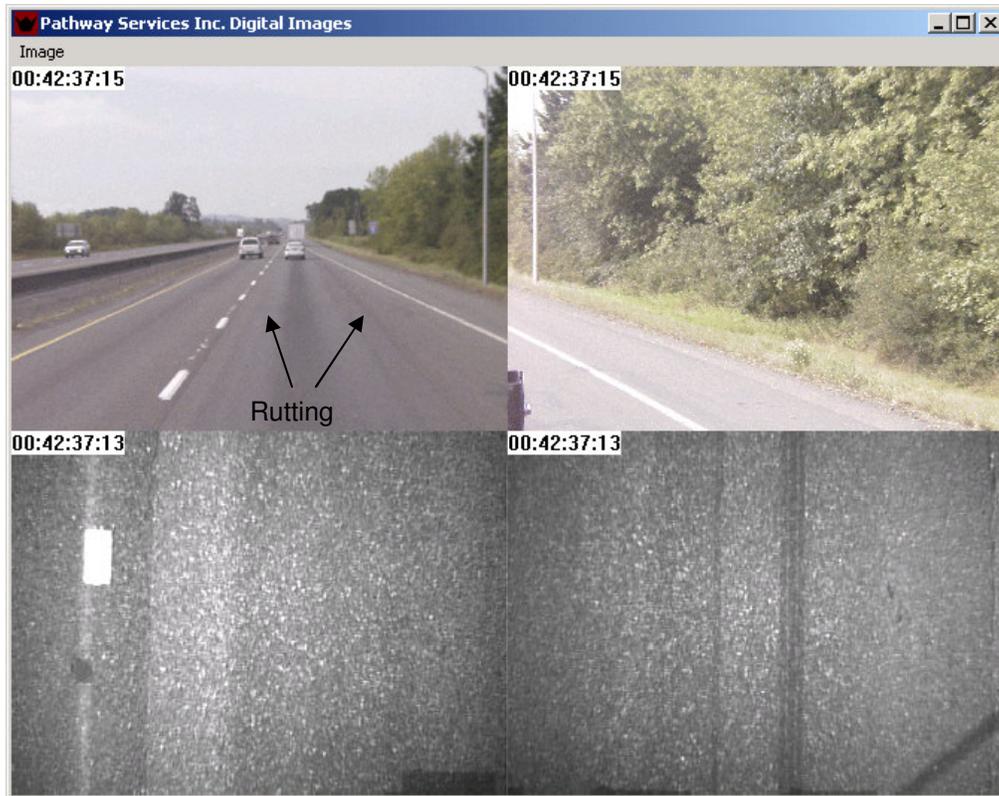
Photo 19. Pavement view in location of rutting (I-5, southbound, milepost 63.00, Toledo vicinity, hot mix asphalt pavement).

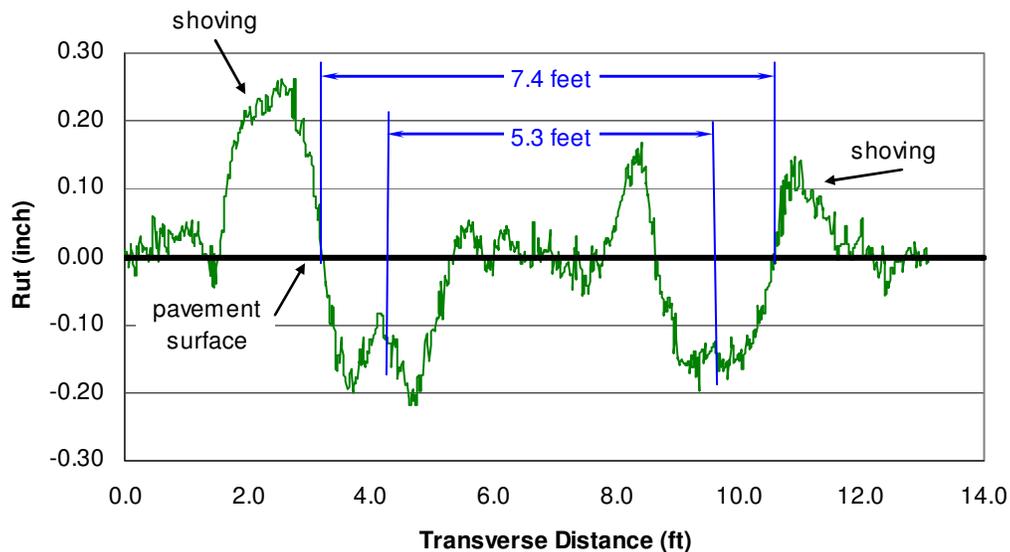
Figure 3. Transverse profile in location of rutting (I-5, southbound, milepost 63.00, Toledo vicinity, hot mix asphalt pavement).
