Re: Woodland State Airport Hangar Review

Attachment B
Structural Examination of Woodland State Airport Letter Report

RE: Structural Examination of Woodland State Airport

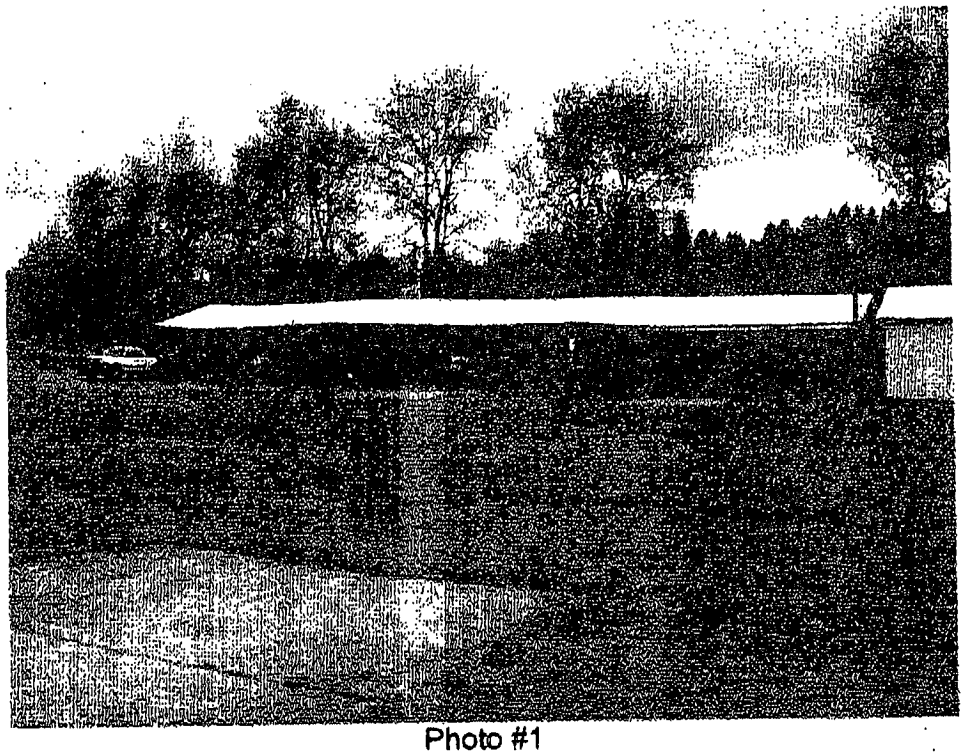
Photo #1
Building A, Hangars 1 Thru 3

supported at the center as well as the front and rear post lines. Roof purlins consist of 2x6 members at 2' to 2'-6" on center single spanned up to 20' with a galvanized corrugated metal roof. The exterior posts generally consist of creosote treated double 3x6 members and interior posts consist of pressure treated 6x6 members. The posts are embedded into the ground and are situated at an alternating 10' and 20' on center spacing with the exterior post lines enclosed by galvanized corrugated metal siding. (See Photos #1 and #2)

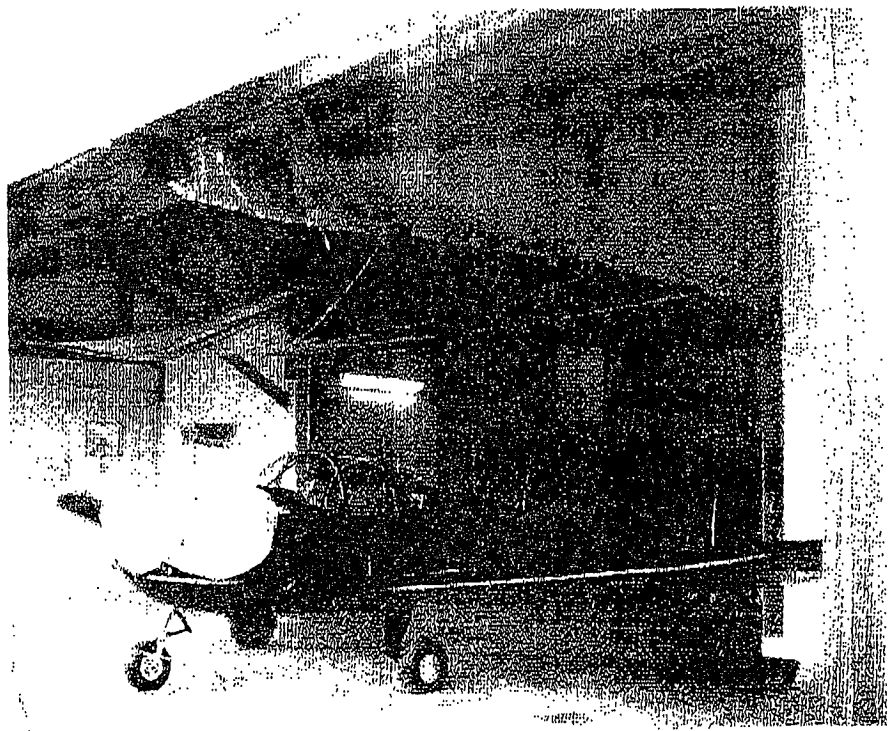
Buildings A and B have been typically modified at the hangar bay openings by removing exterior supporting posts to accommodate the required bay openings. A few of the hangar bay openings have door systems of different construction installed and many others are open to the elements. In some locations, replacement 4x4 posts were installed with hinges at the exterior truss bearing point to apparently allow the post to be moved up out of the way and then returned to a supporting position. However, each of the posts installed in this manner have been tied up in the open position and provide no support. In a few locations, the original posts have been cut off above the ground and spliced to replacement posts. In building A, all of the hangar openings and missing posts are located along the west wall line. In building B, the hangar openings and missing posts are alternated between the west and east wall lines. (See Photo #4)

Photo #4
Cantilevered Framing Typical, Hangar 8

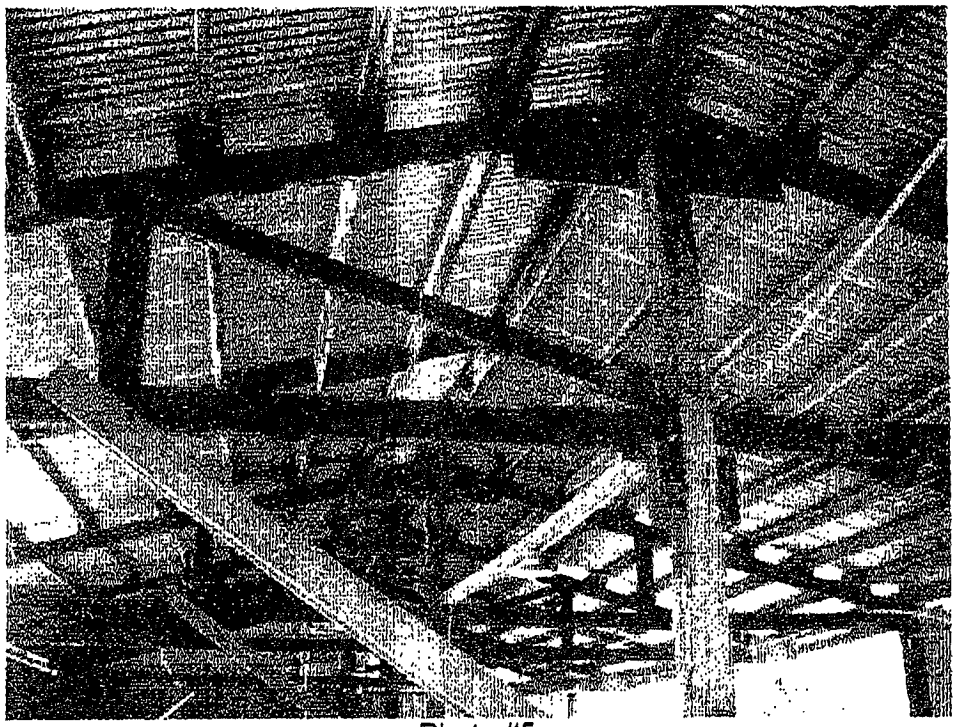
The gabled, wood framework supporting the roof joists generally consist of creosote treated 3x6 wood members framed into the interior bearing post from each side and connected at the eaves to form a truss type configuration. At locations where the exterior post was removed or modified, the tails of the truss- type framework is cantilevered out 16' with a 16' back span. An intermediate vertical member is present at each side near mid-span and a diagonal member is typically installed on the cantilevered side. Connections at the tails and panel points vary, but generally consist of plywood gusset plates at one or both sides with 3/8"-1/2" through bolts and varied nailing patterns. Many interior panel connection points for the vertical and diagonal members have no gusset plates or obvious connection. (See Photo #5)

In several areas the truss type frame work has been modified further with additional vertical and diagonal scab members and or strapping in various configurations to provide additional rigidity. On the cantilevered end side of the framework, additional diagonal knee braces have been installed in various configurations. These braces typically consist of single or double 2x6's attached to the interior post and out to near mid span of the framing. These connections also vary with through bolts in some locations and minimal nailing in others. Many of the installed knee braces are buckling out of plane up to 1" or more and several nailed connections are beginning to separate. At a few locations, 1/2" steel tie rods with angle clips, between the top and bottom chords, were installed in place of knee braces. The angle clips are bending slightly and crushing at the back of the through bolt connection. (See Photos #5 and #6)

The gable truss-type framework supporting the roof joists are not supported or constructed as true trusses. Typical truss design for hand built trusses requires careful attention to connections at the joined members. The observed geometry and existing connections do not even closely appear to be adequate. This is evident in the necessity of the numerous additional supporting knee braces, tie rods and scabs that have been installed to the framework over time. The design and connections of which are also not entirely sufficient as several are failing. As a result, the roof framing is deflected and sagging in many areas under dead load alone. Increased or full required design vertical loading could be expected to cause full or partial collapse in many areas.

Photo #5
Truss Type Framing Support. Buildings A and B

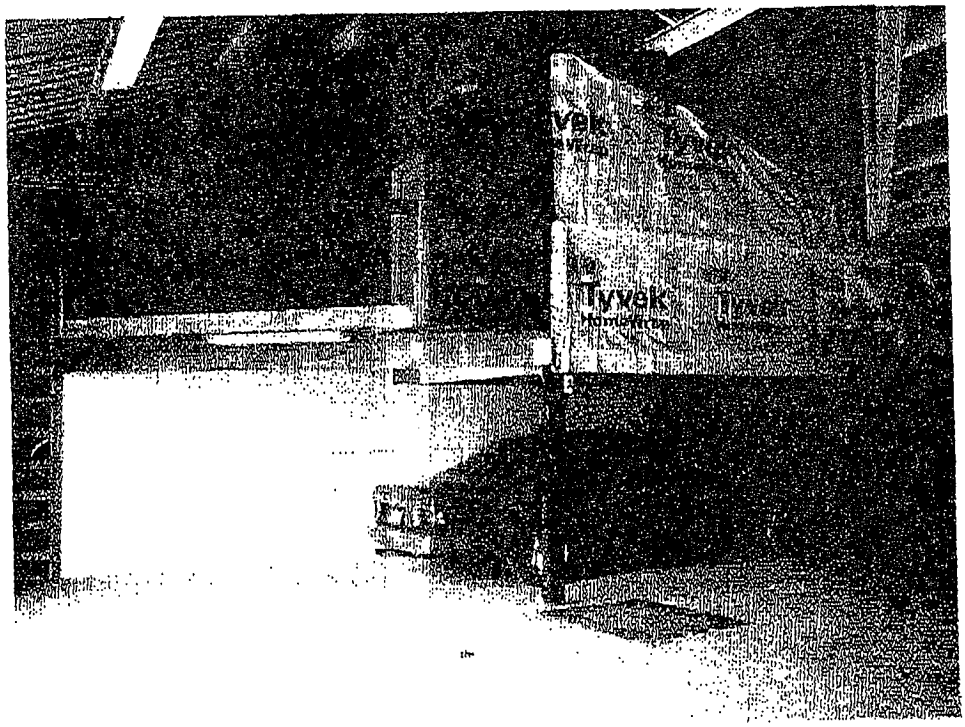
Photo #10
Mezzanine With Enclosed Storage Space, Hangar 13
