APPENDIX I
CONSTRUCTION MONITORING MEMORANDUM

Technical Memorandum

To: Norman Norrish (Wyllie & Norrish Rock Engineers)
From: Balin Strickler (Fisher & Strickler Rock Engineering)
Date: January 26, 2009
Re: Persistent Discontinuities – Interstate 90, Hyak, Washington

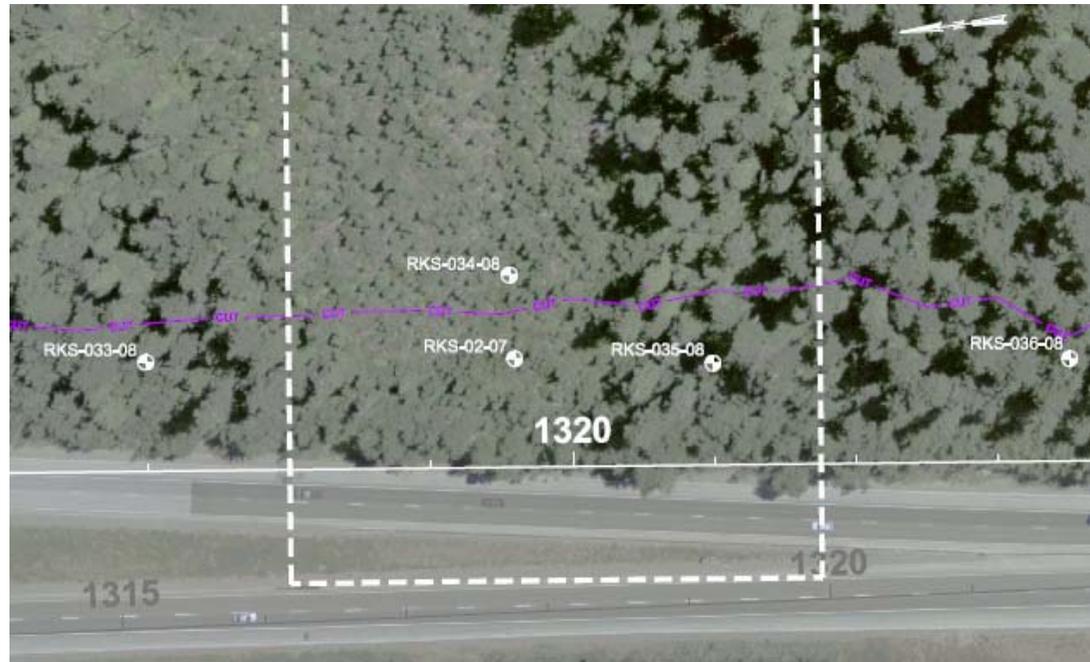
This figure is based on general geology for Sector III but should not be considered design information. The images and discontinuity orientations are for illustration only.

During excavation of Sector III, intersection of the northern and southern arms of this boundary is highly probable. Initially, the lateral arms will appear to be independent, persistent, and possibly adverse features with no apparent complementing feature to form a large wedge or bowl shaped failure when compared to the sector joint sets and discontinuity database (Figure 1). Therefore, likely mitigation measures for one of the arms would only address small scale block or wedge failure associated with the joint sets previously identified and spot bolting and possibly shotcreting at select locations. Additionally, in the case of this flow boundary the first exposure of the lateral arms could place them a few hundred feet apart. Without geologic and structural correlation between the two persistent features it is likely that the mitigation measures implemented would not be adequate for the size and persistence of the structure.

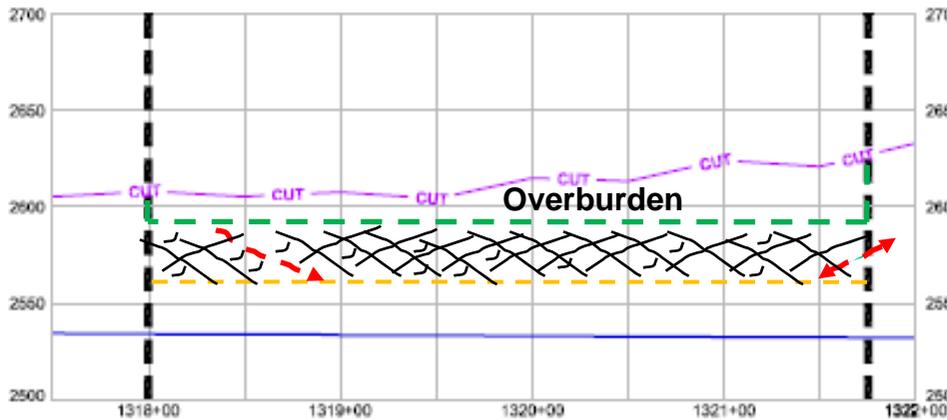
First Lift

PROFILE

Note the red discontinuity lines in both profiles. Absence of early detection and mitigation design (during the first lift) could result in an unstable slope with potential for large scale failure.

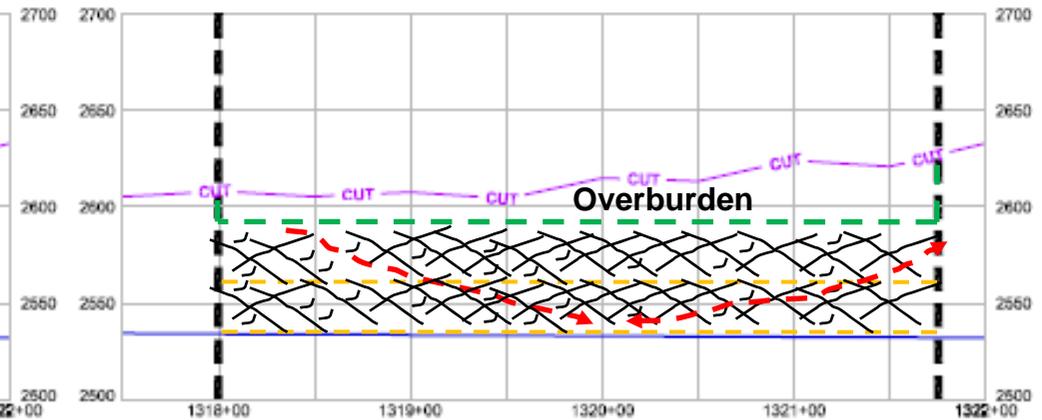
Second Lift

PROFILE
